**PRELIMINARY REPORT ON  
OBSERVATIONS FROM 16 APRIL  
2013 IRAN EARTHQUAKE  
(PAKISTAN SIDE)**

**Muhammad Masood Rafi**

**Department of Earthquake Engineering**

**NED University of Engineering and Technology,  
Karachi, Pakistan**

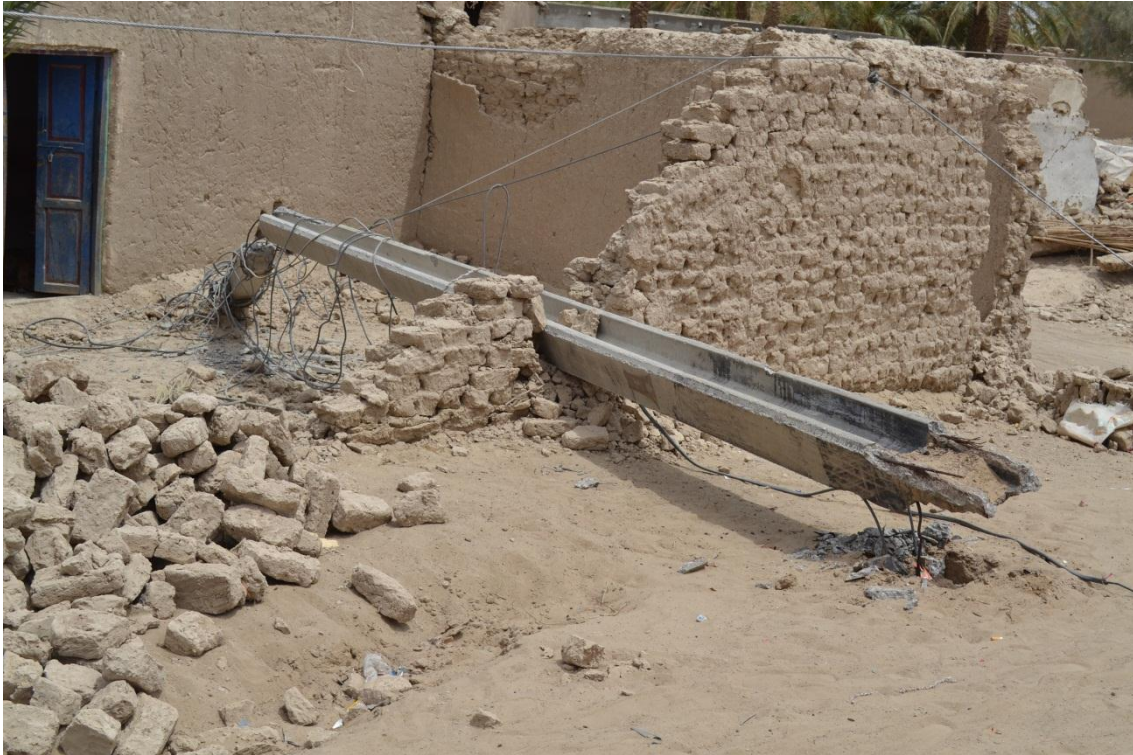
The infrastructure facilities in the area consist of electric poles and sewerage lines. Ground wells are the major source of water supply and the roads are non-existent in the region. Insignificant damage was observed to any of these infrastructure facilities in the affected areas. Except West Zawag, no damage to electric poles was observed (Fig. 2). All poles were, however, damaged in West Zawag (Fig. 4). The wells were also functional in the area. Similarly, telecommunication infrastructure was also intact and the mobile phones were functioning satisfactorily.

Fig. 4 Broken electricity poles in West Zawag

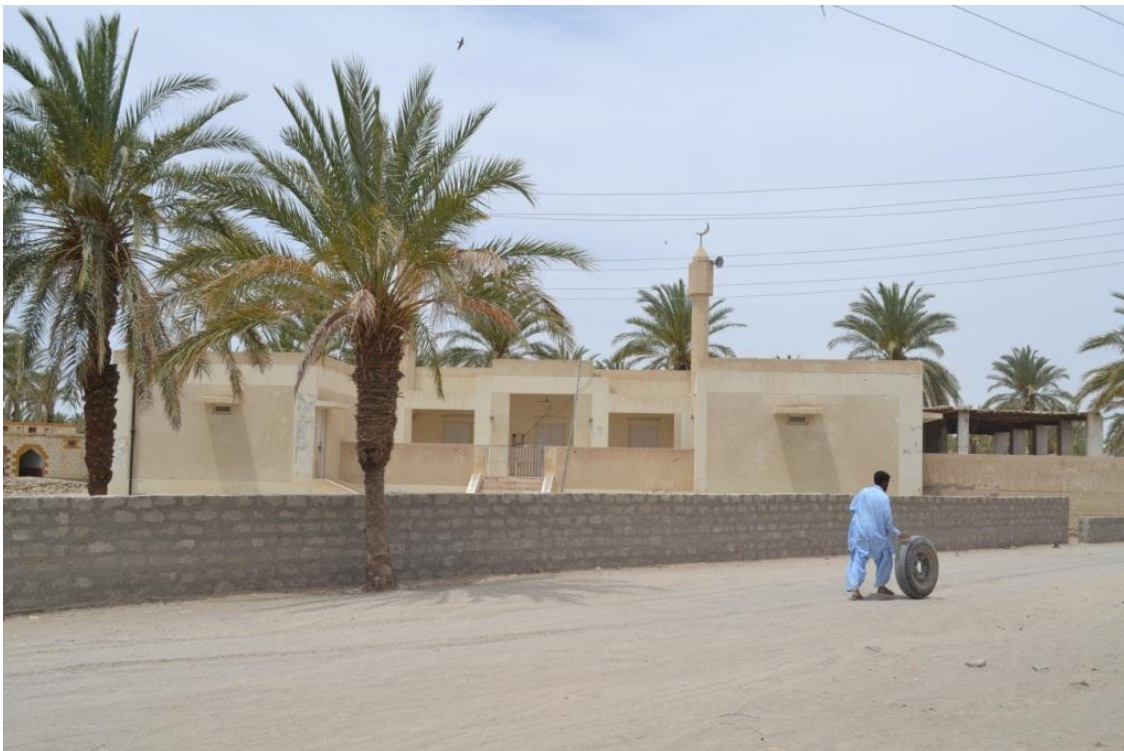
In respect of material types, RC buildings performed well and were undamaged (Fig. 5). Minor damage to block masonry houses was observed in the Mashkel city area (Fig. 6). The adobe buildings performed poorly, as can be expected and suffered huge losses (Figs. 7 and 8). According to some of the reports (these are not verified by the team) nearly 45,000 people were affected in Mashkel out of a total population of 48,000 whereas 5,470 houses were damaged.

Fig. 5 View of a RC structure of a mosque in West Zawag

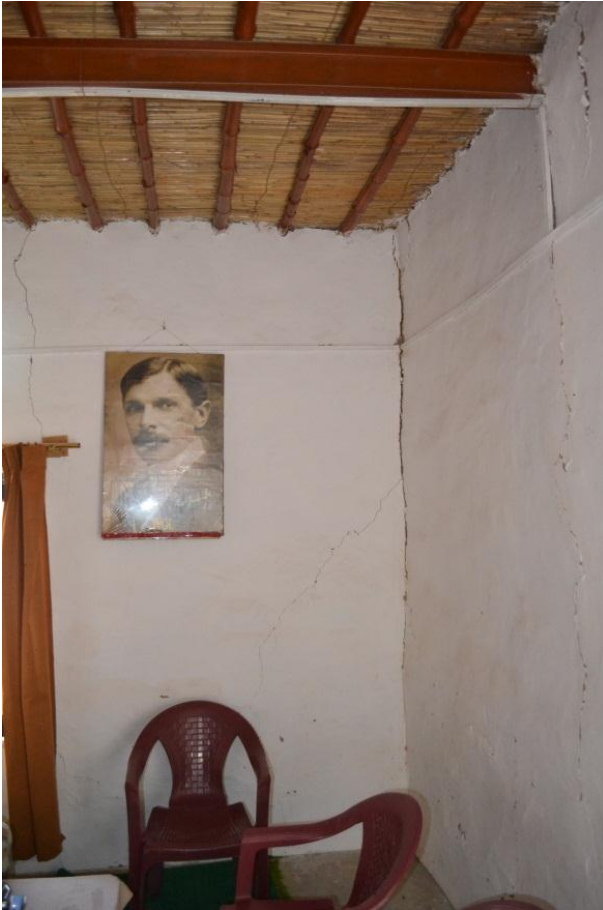
Fig. 6 Cracking in block masonry building in FC Headquarter

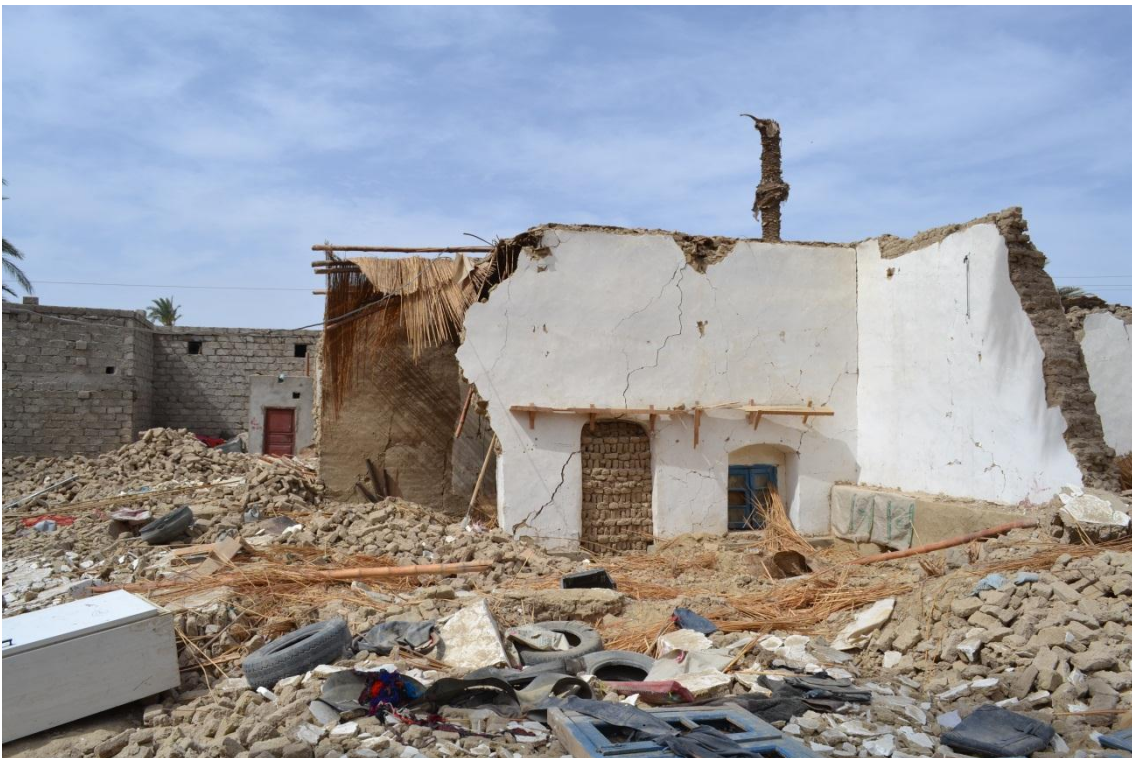
Fig. 7 Damaged adobe buildings in East Zawag

In respect of surveyed area, East and West Zawag suffered the maximum damage and most of the adobe buildings collapsed in these parts (Figs. 7 and 8). A historical adobe castle in the FC Headquarter was also heavily damaged (Fig. 9). Building damages in the kilis varied. Most of the building damages were noted in Kili Kallag. These damages include from cracking in the wall to the complete building collapse (Figs. 10 and 11). Minor damages were observed in the rest of the kilis (Fig. 12).

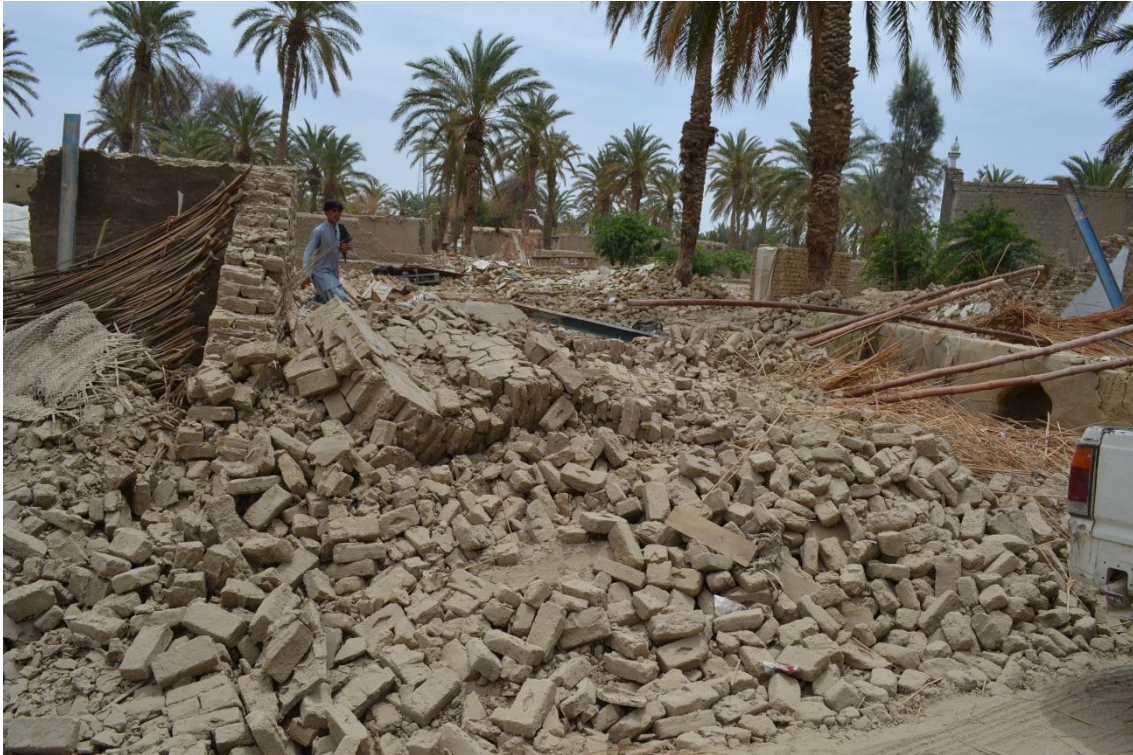
Fig. 8 View of damages in West Zawag

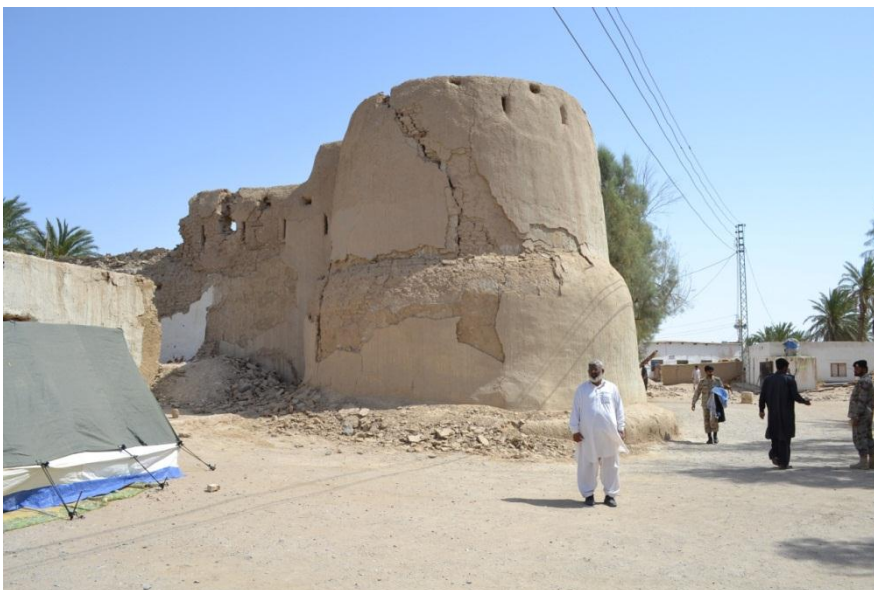
Fig. 9 View of damaged castle in FC Headquarter in Mashkel

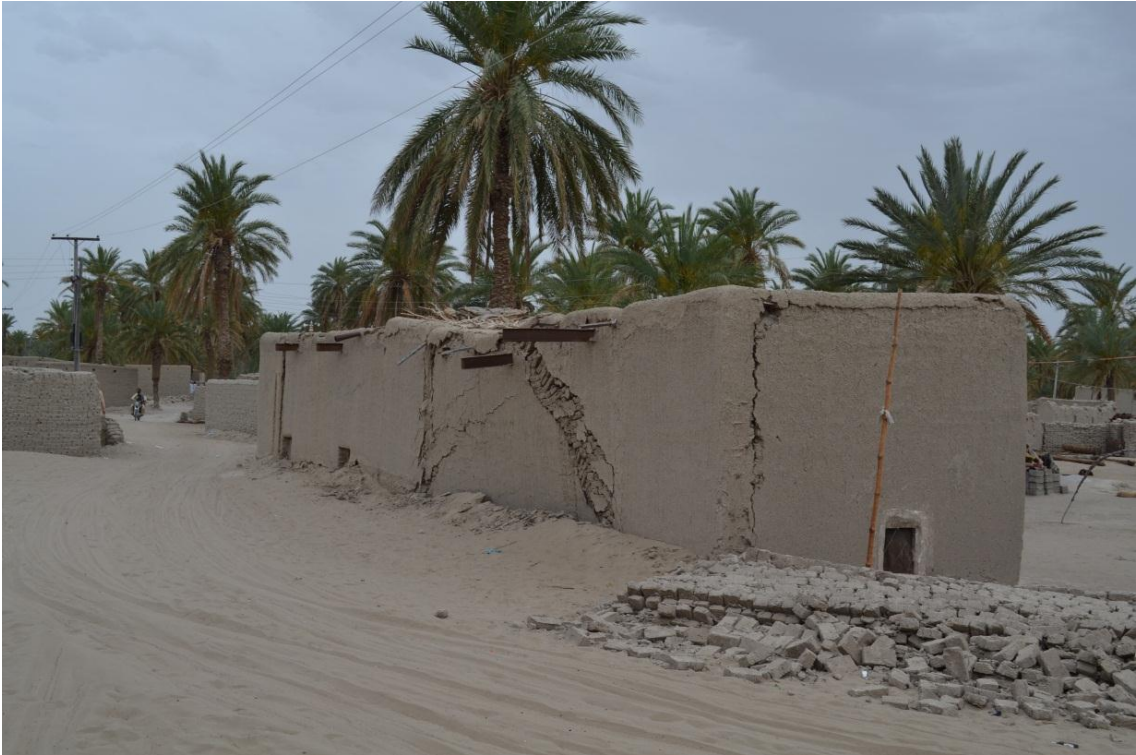
Fig. 10 Visible crack in walls in adobe buildings in Kili Kallag

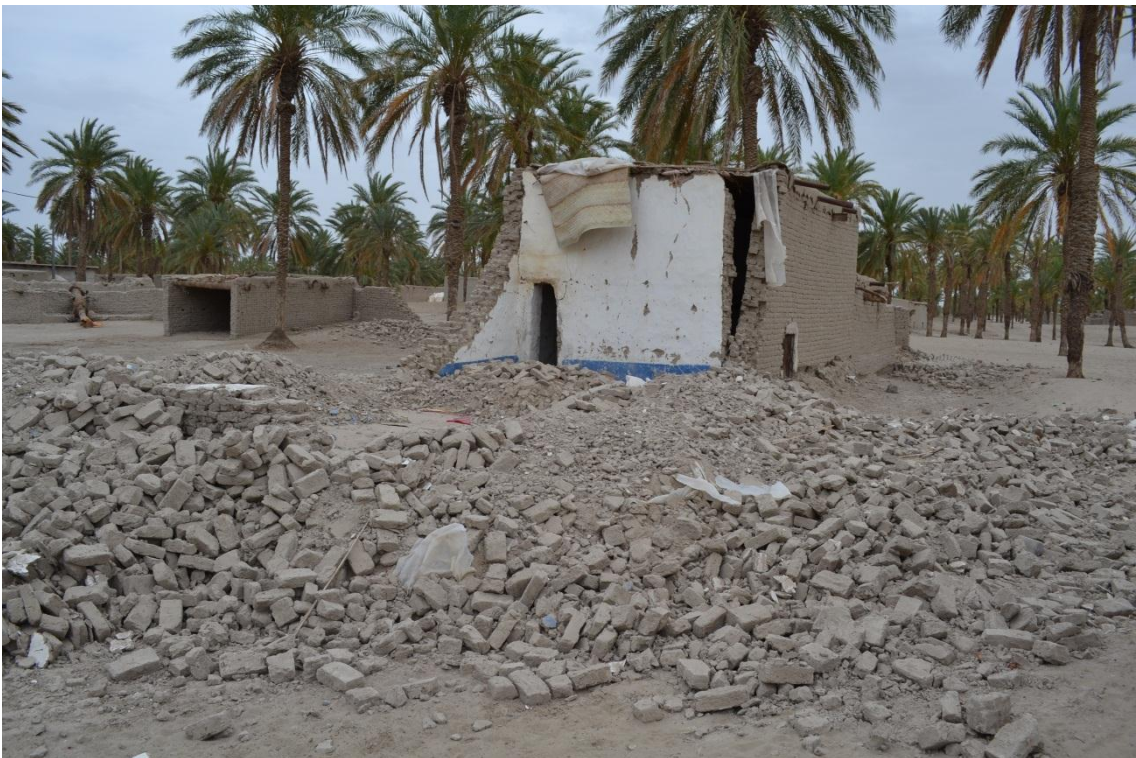
Fig. 11 Damaged adobe houses in Kili Kallag

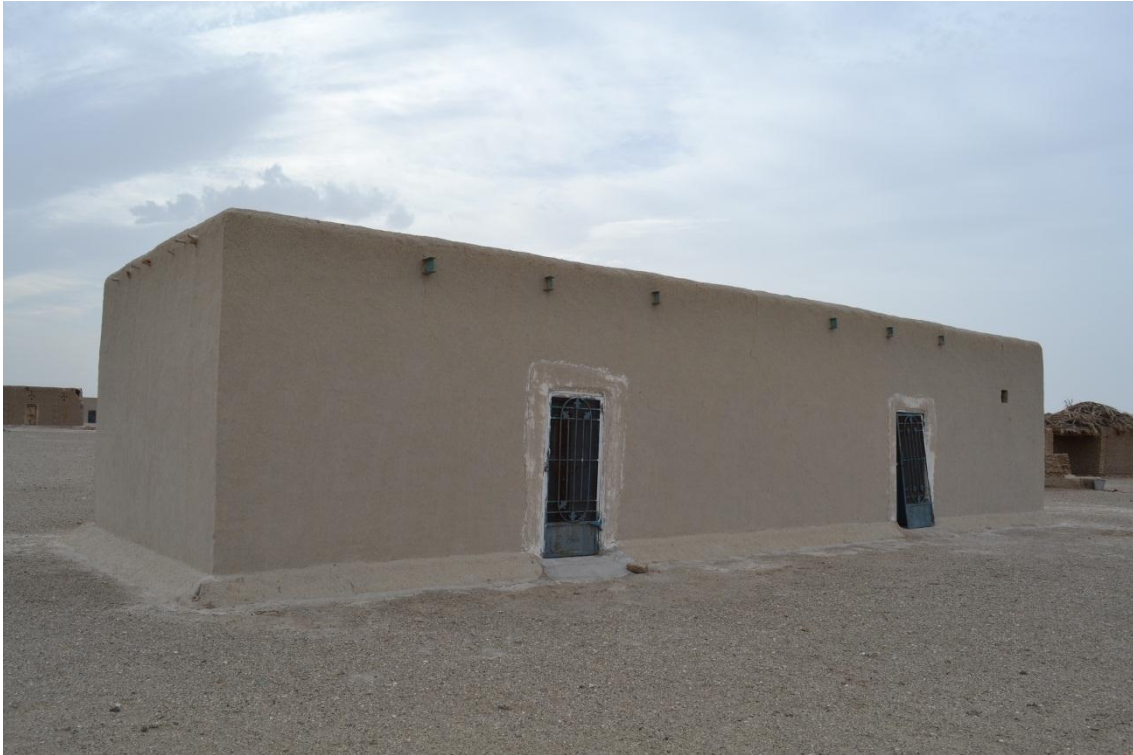
Fig. 12 An adobe house in Kili Tachap after the 16 April 2013 earthquake
