February 6, 2016 (local time)
M_L-6.4 Meinong Earthquake
Kaohsiung City, Taiwan

2016/02/06 – Ver5.0

2016.02.06 Meinong Earthquake

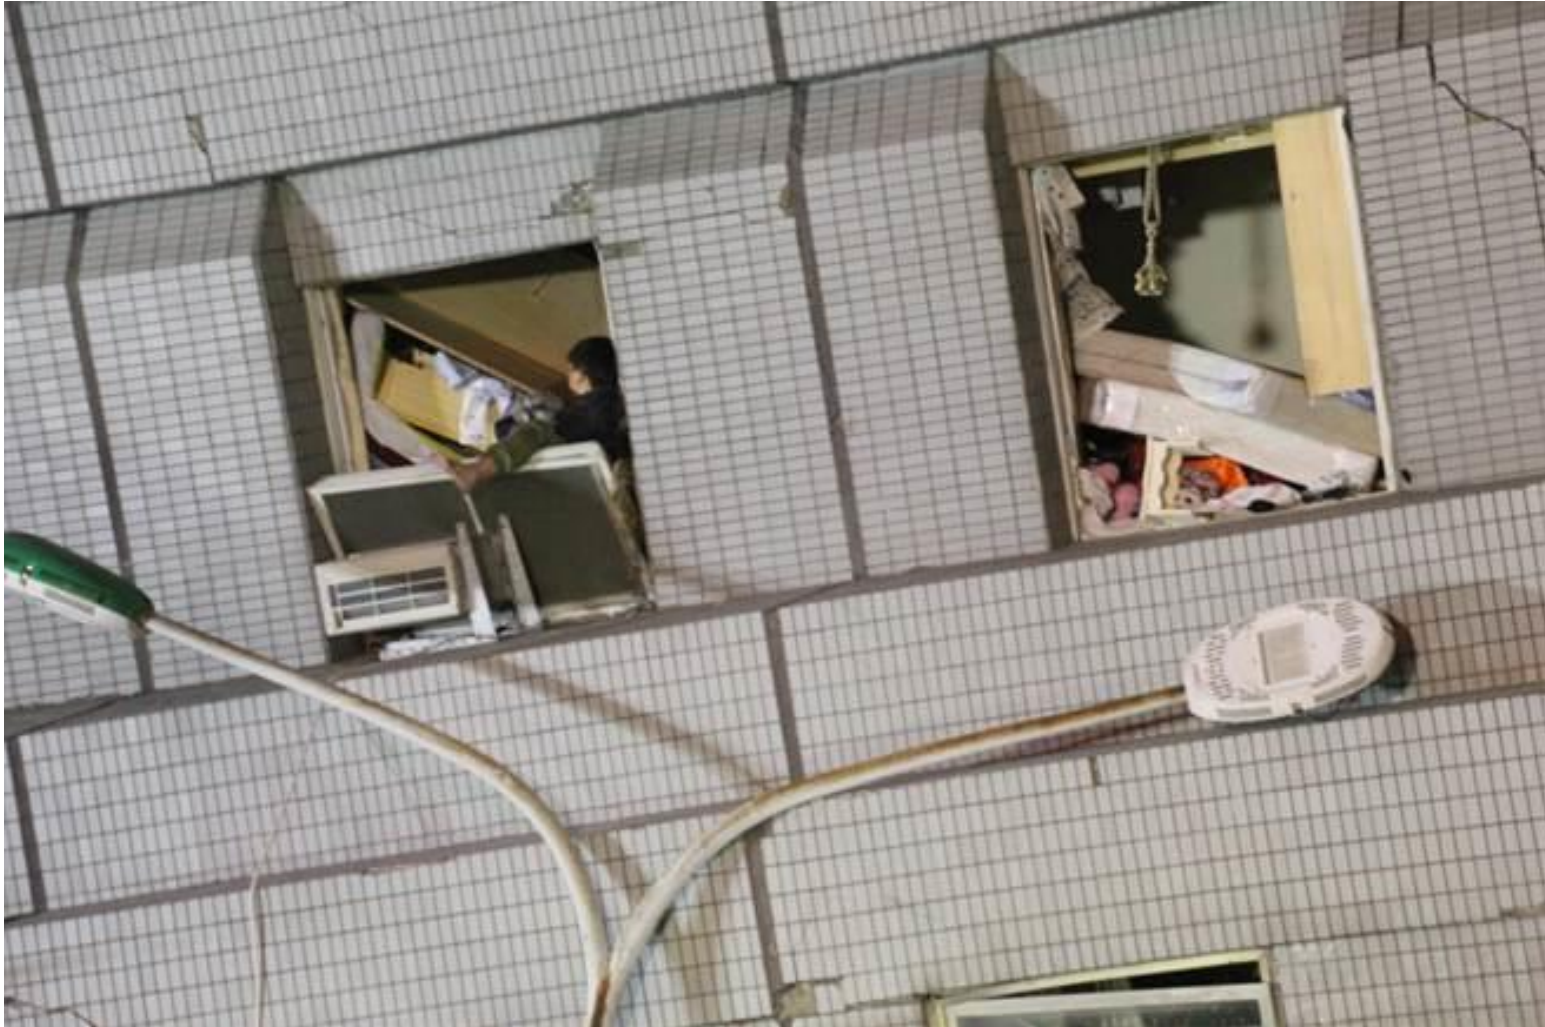
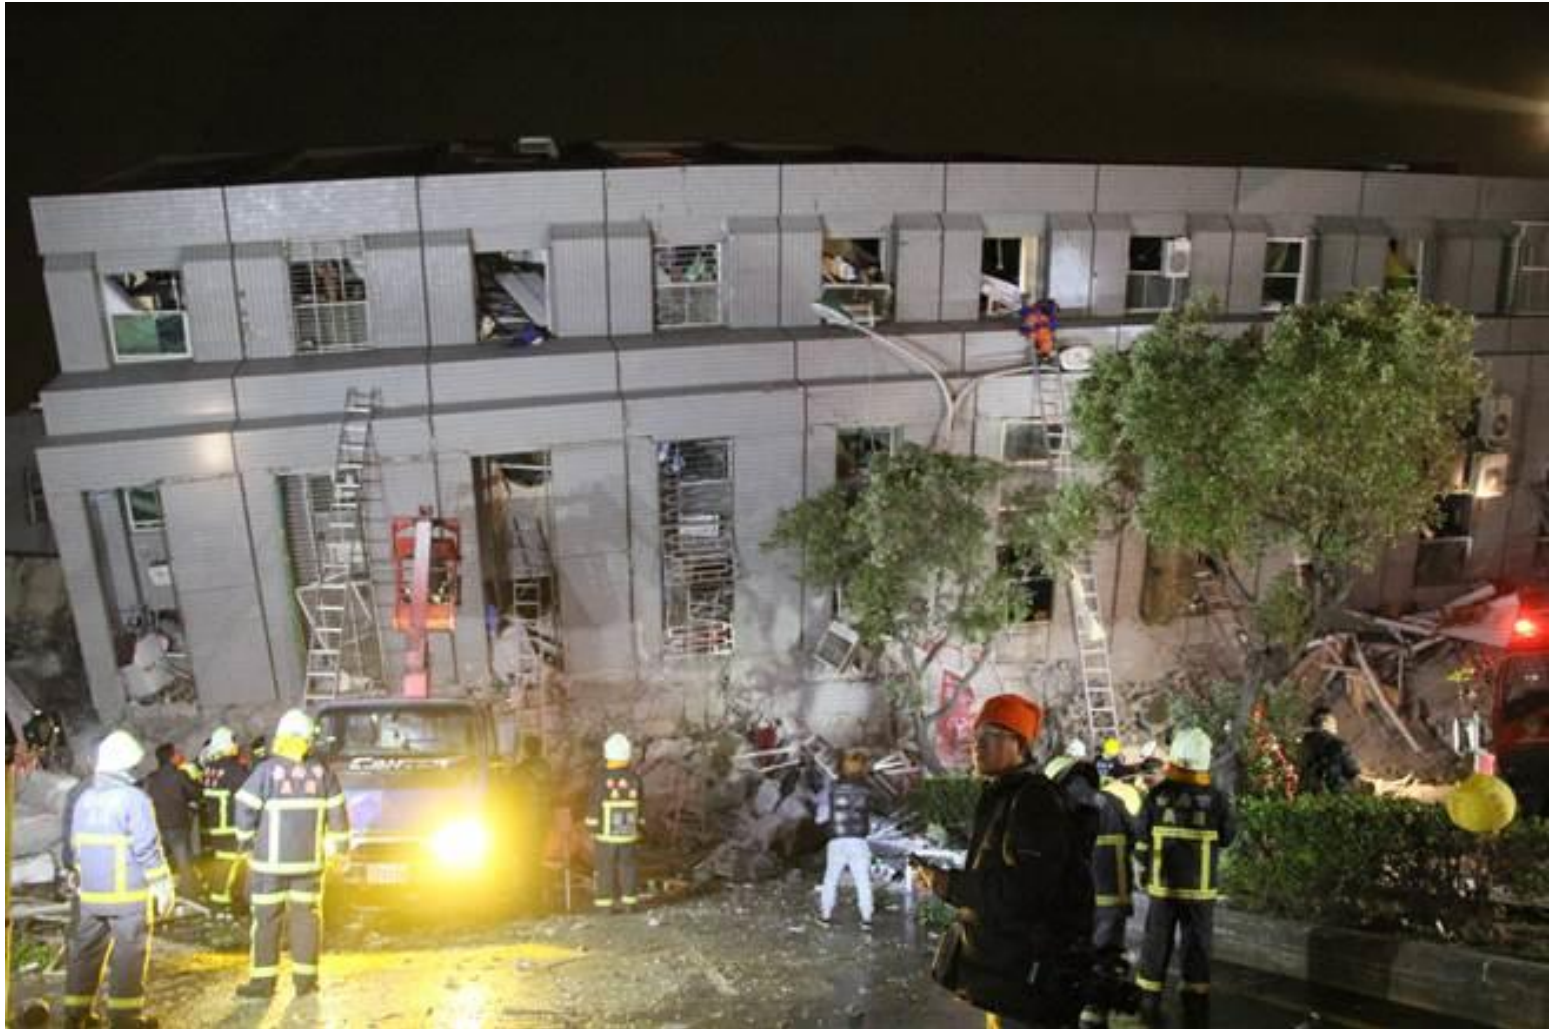
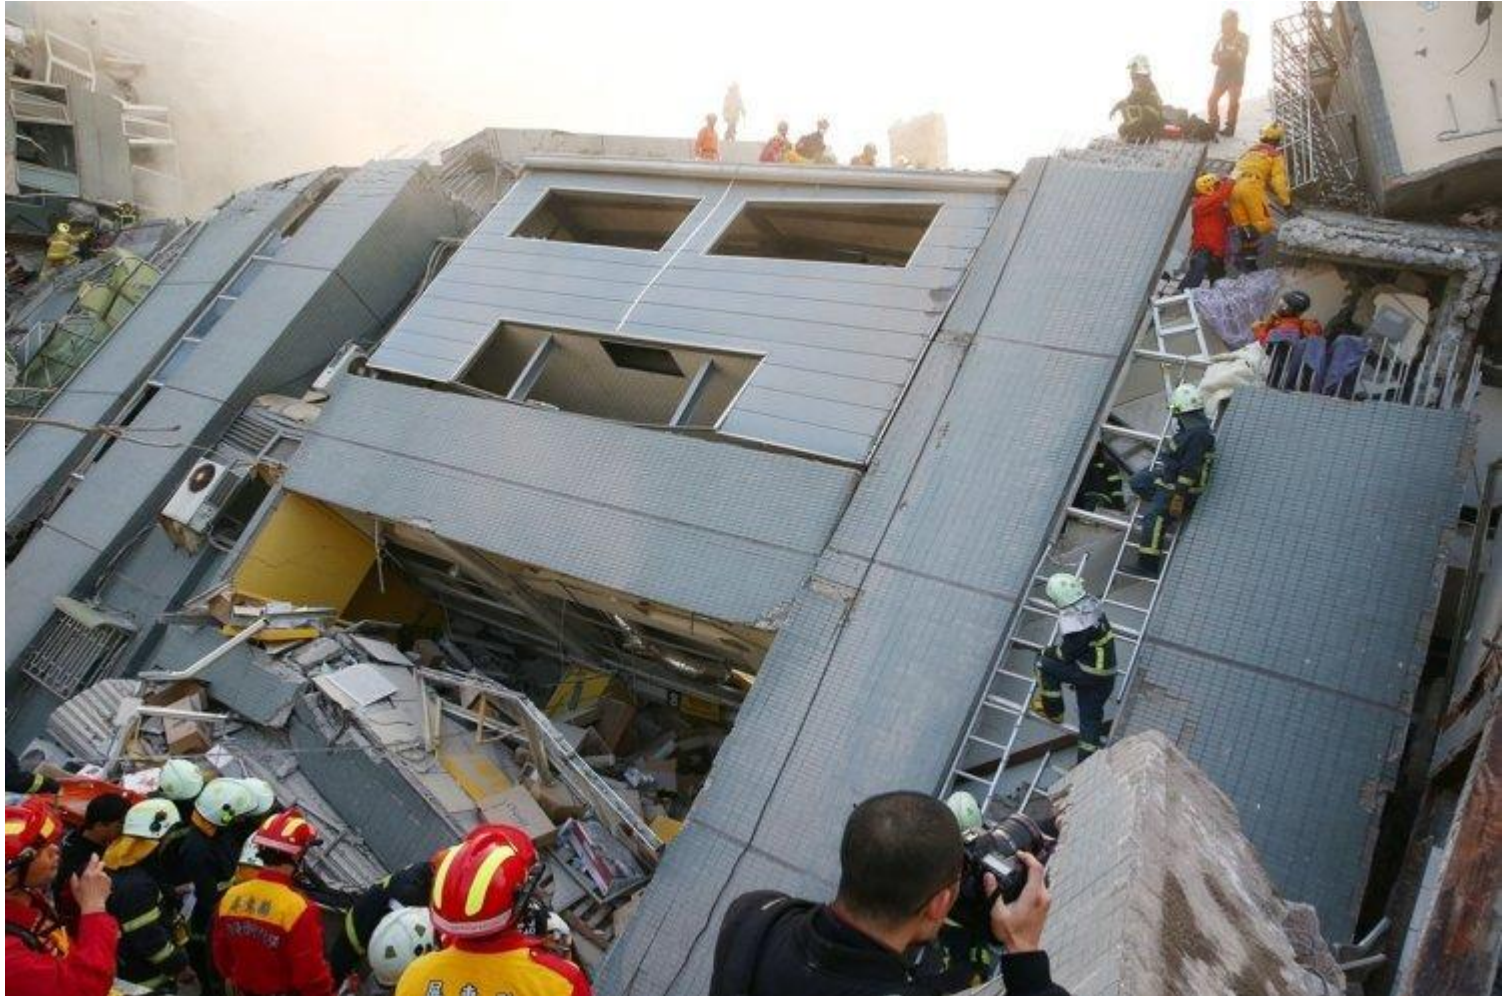
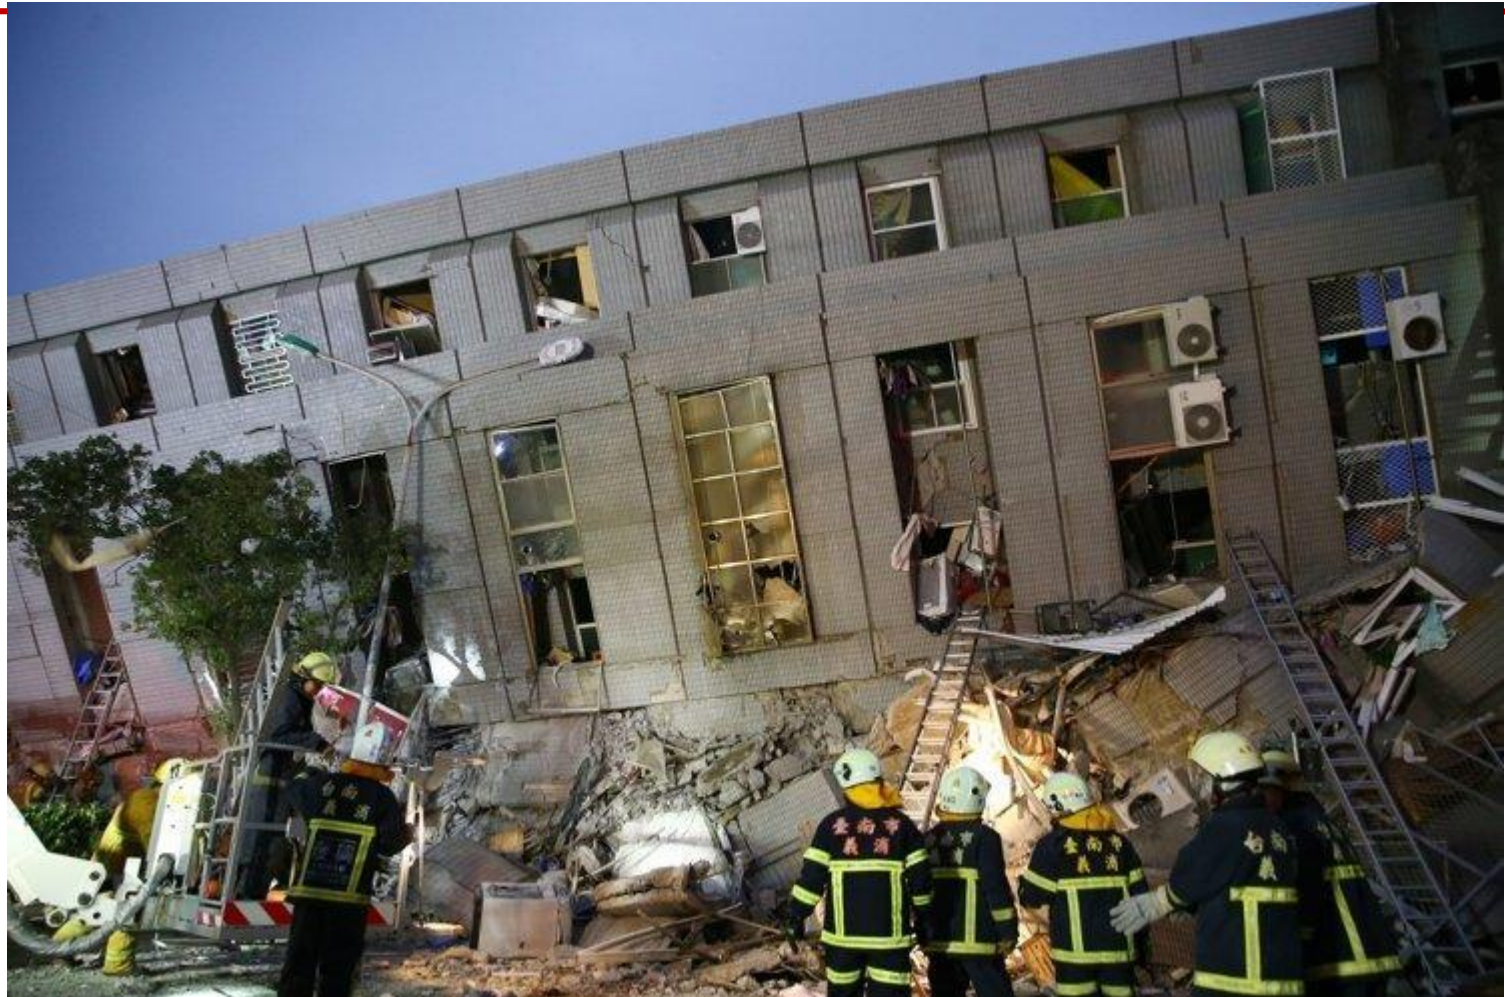
(1) Weikuan Jinlong (維冠金龍/燦坤) Complex

- On Section 2, Yongda Rd. and Guoguang 5th St., Yongkang District, Tainan City
- 16-story RC building collapse

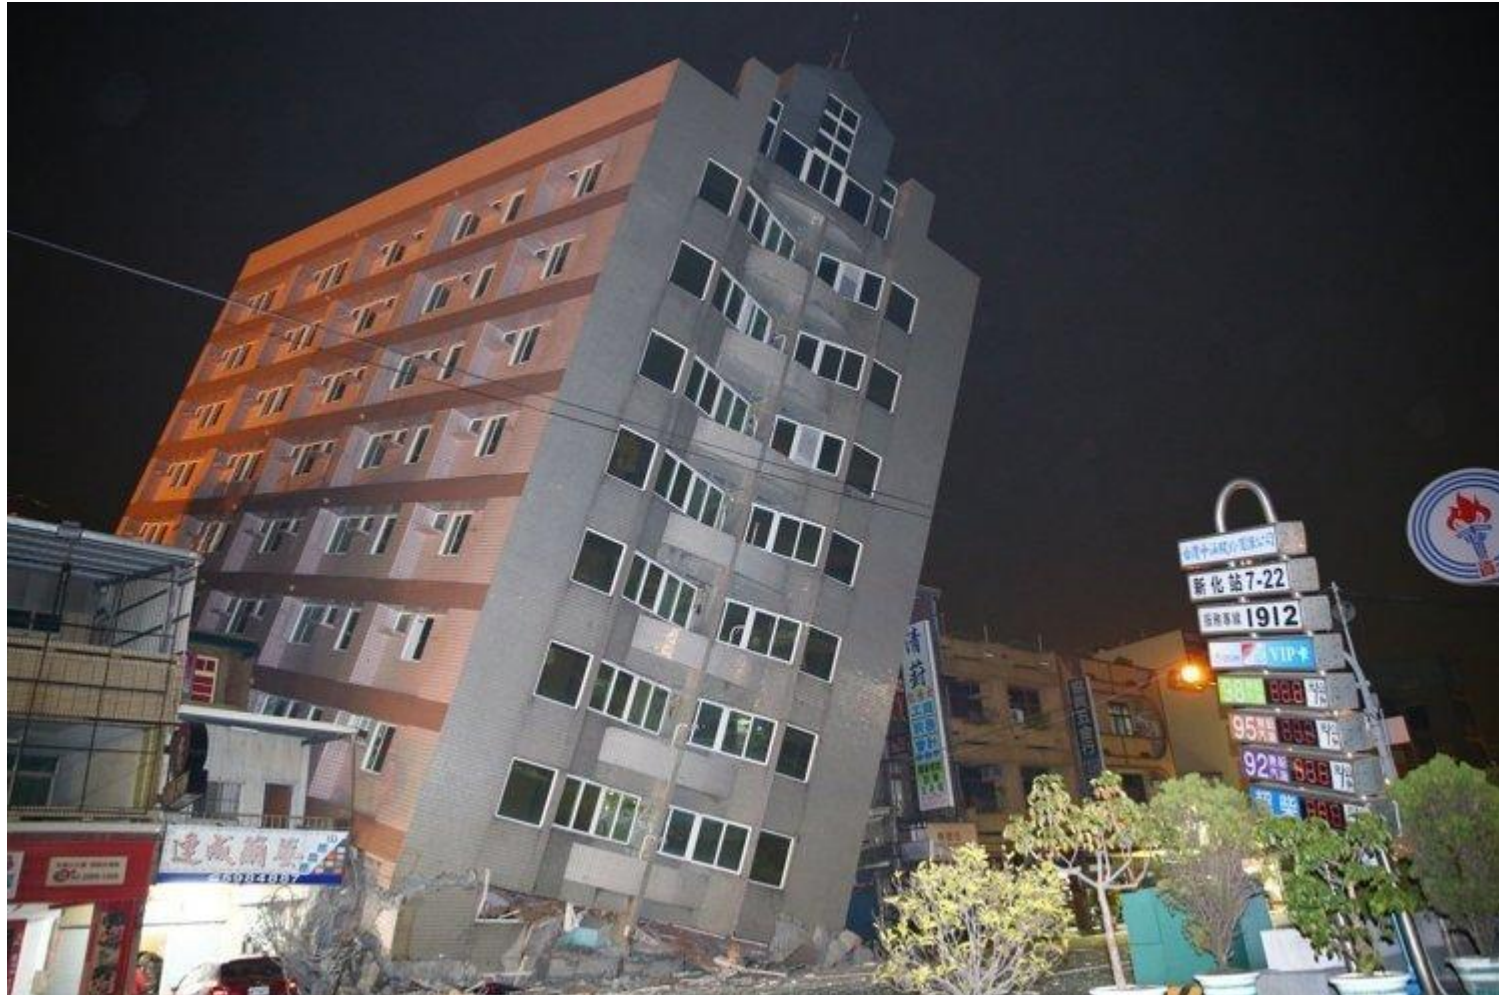
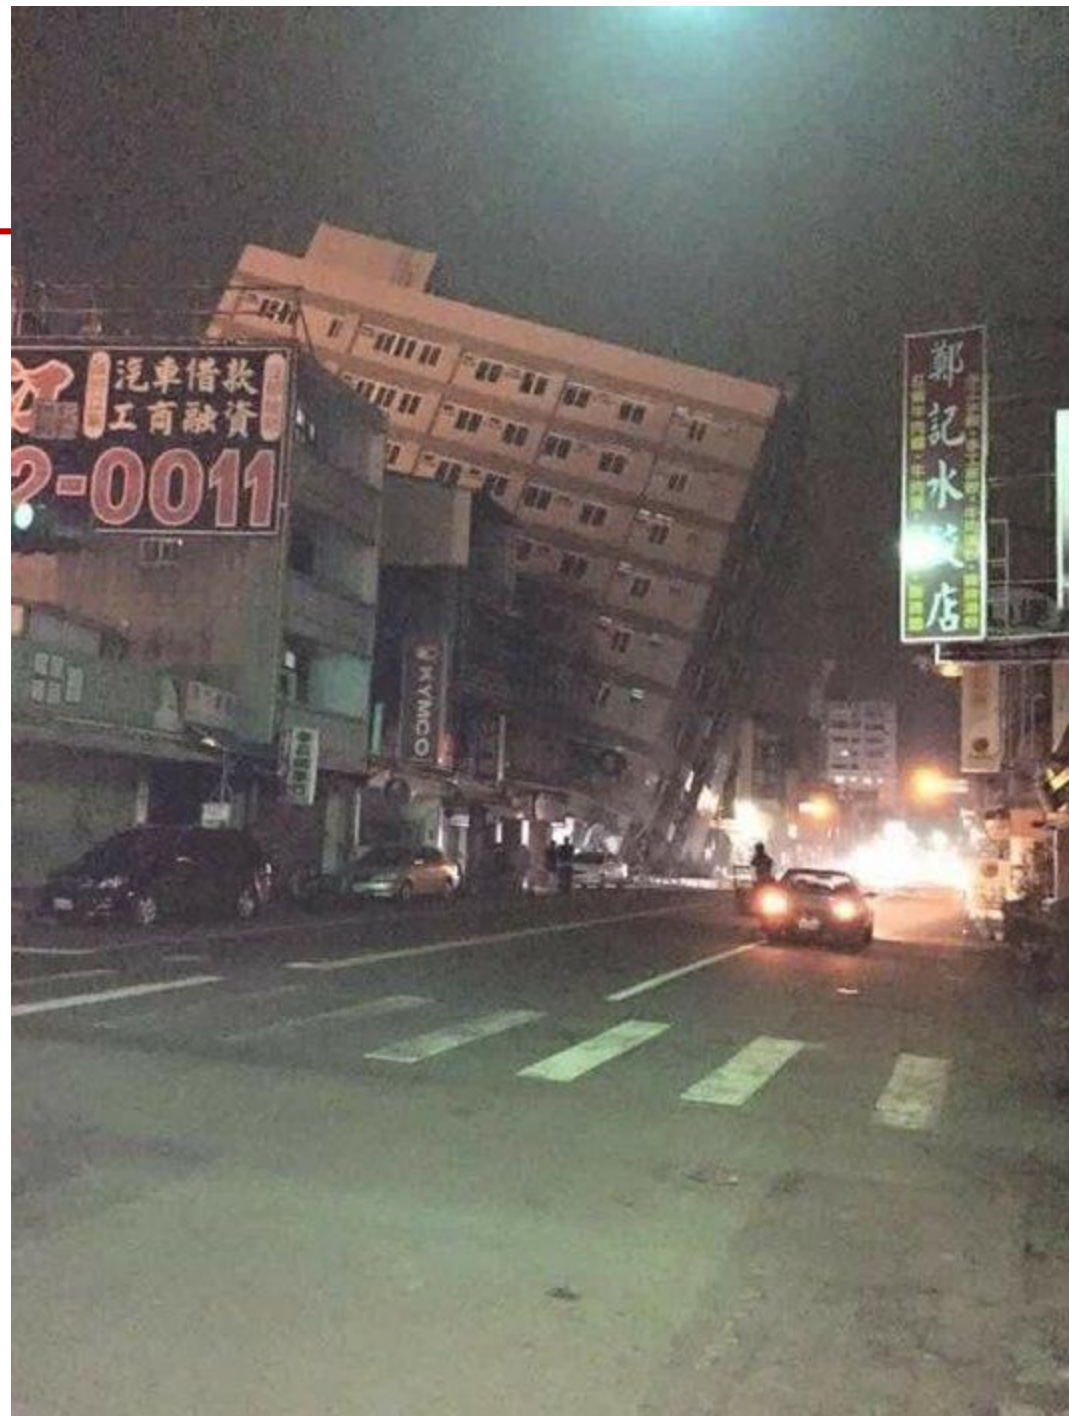
Photographical View of King's Town Bank (京城銀行) after Earthquake

- 586 Zhongshan Rd., Sinhua District, Tainan City
- 10-story

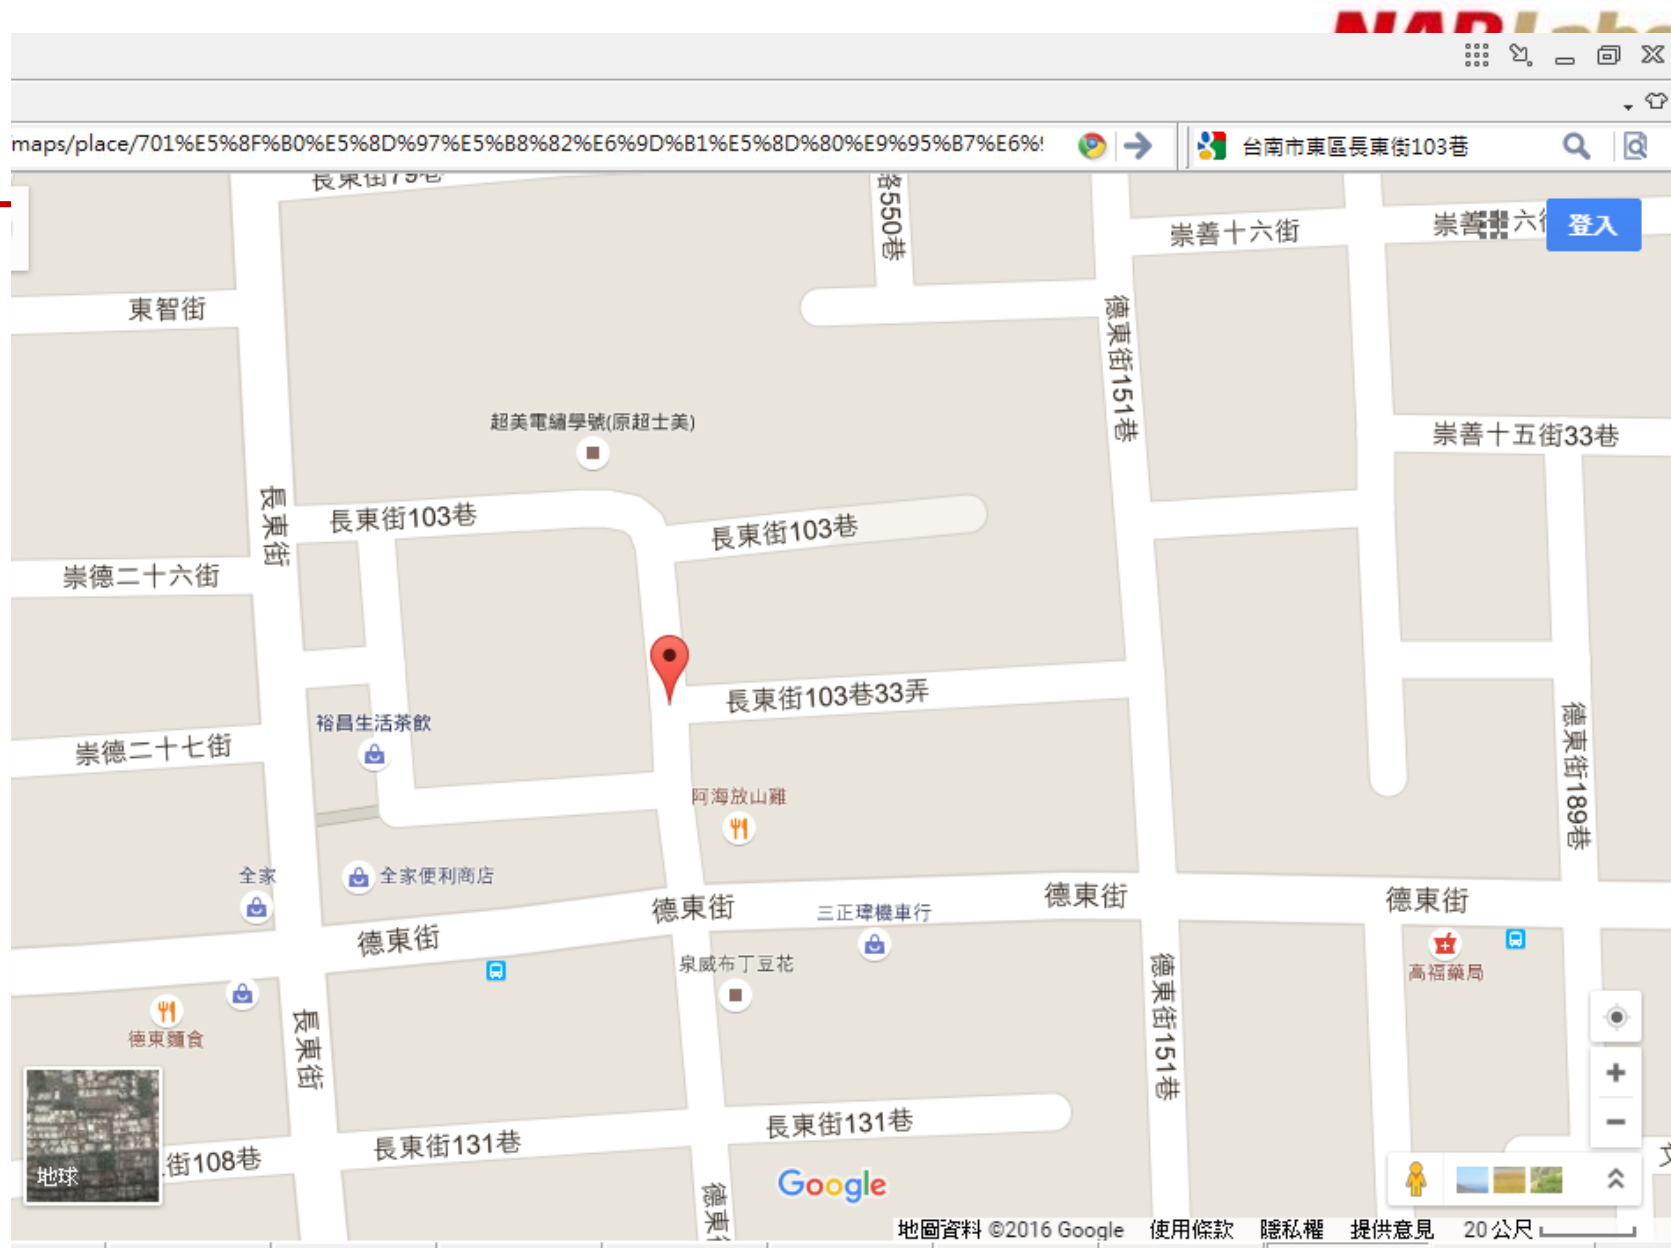
(3) Dachih Market Place, East District

- Lane 103, Changdong St., East Dist., Tainan City
- Commercial-residential complex building (4-story above ground, 1-story underground)
- Soft 1st story collapse, some of 4-story buildings became 3-story

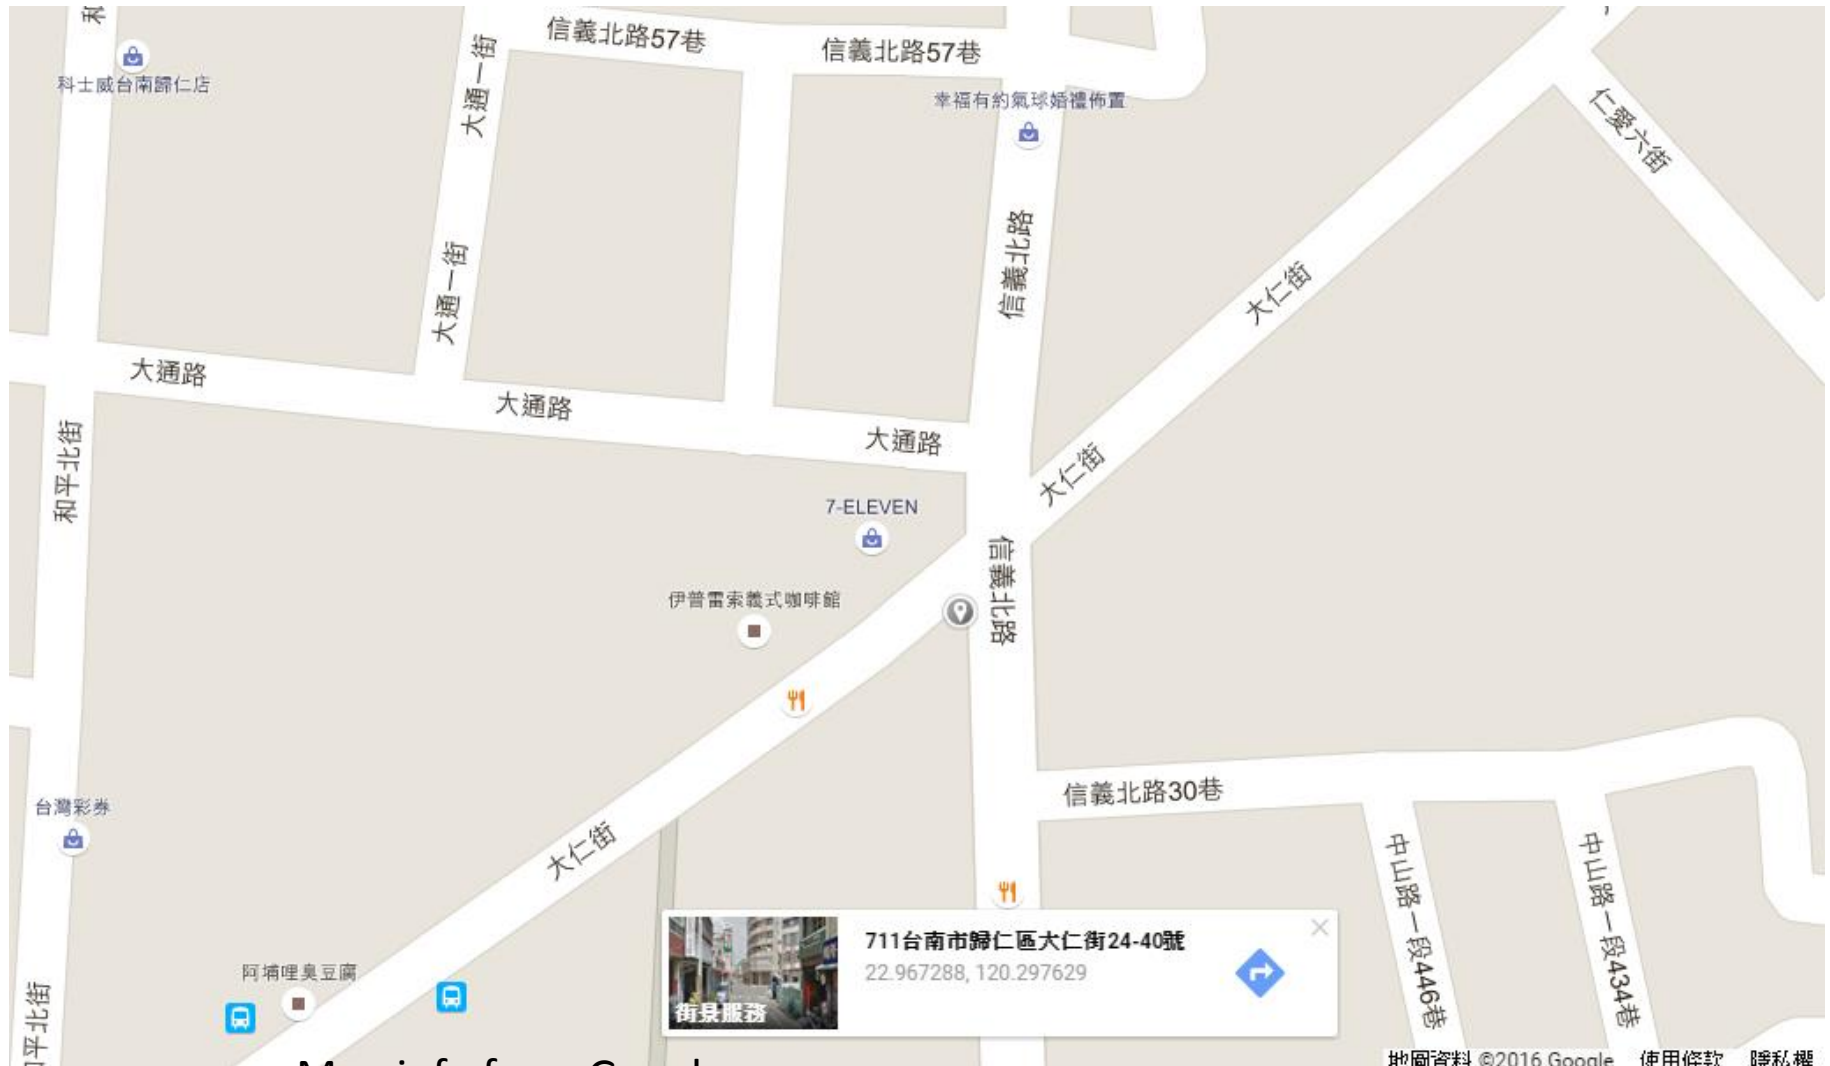
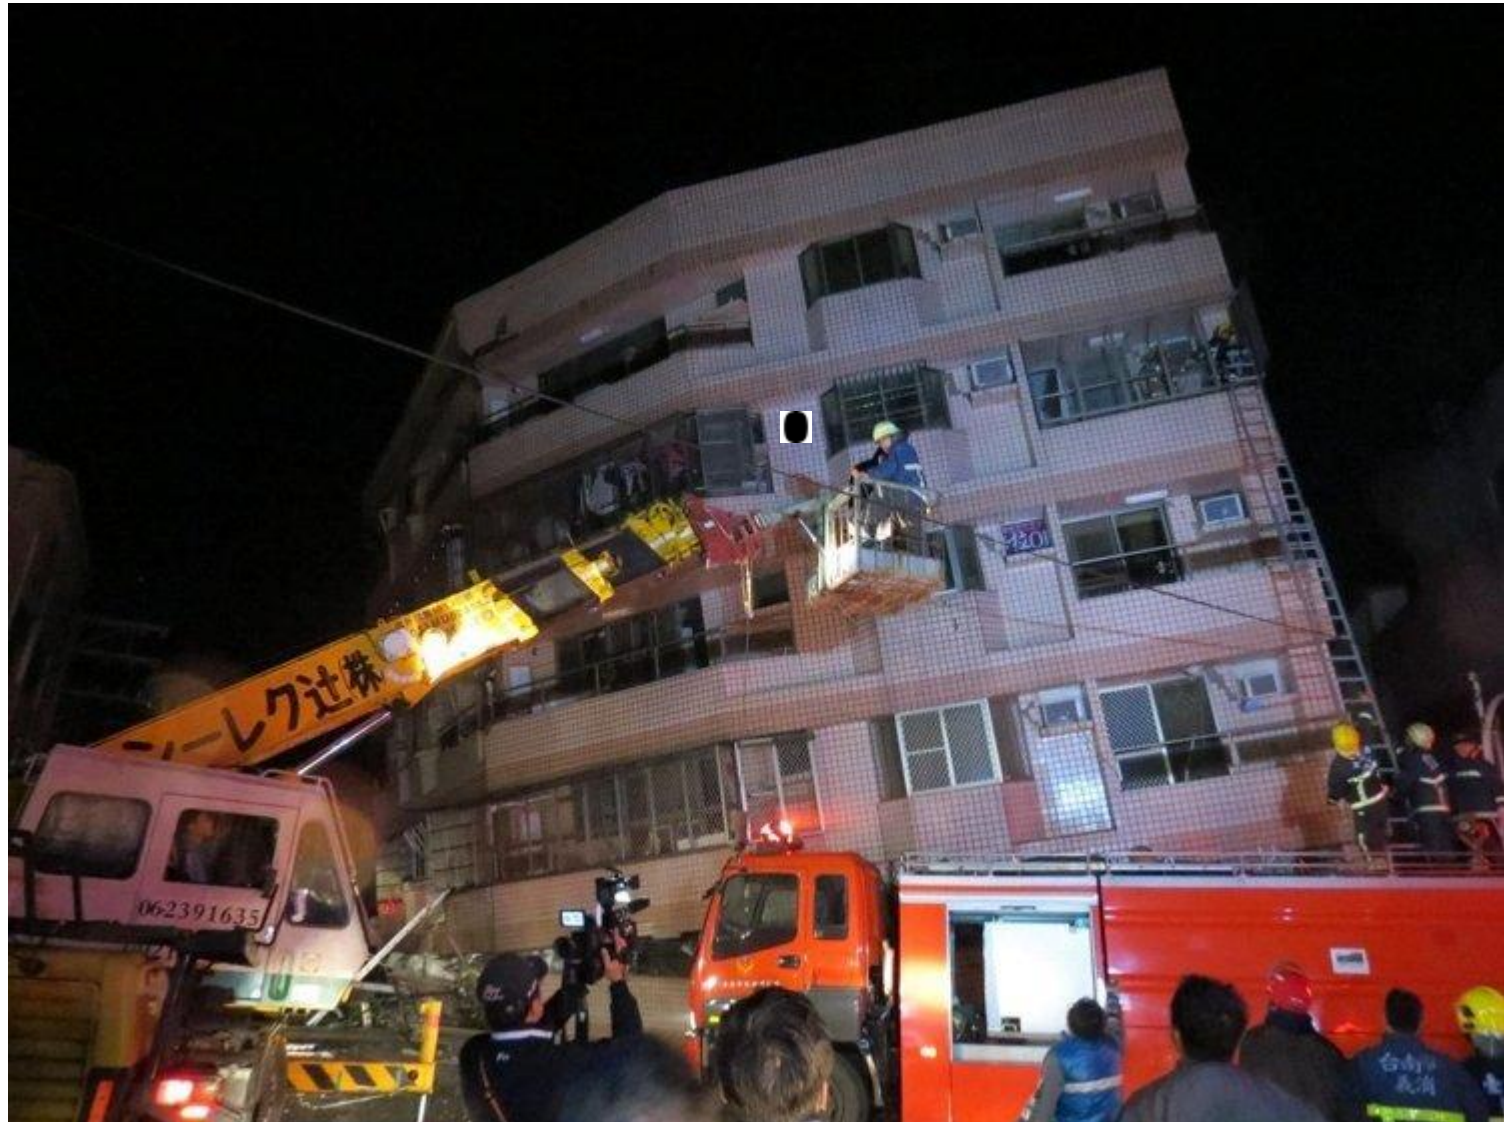
(5) On Xinyi N. Rd. & Daren St., **NAR Labs** Guiren Dist.

- 46 Xinyi N. Rd., Guiren Dist., Tainan City
- 6-story RC building

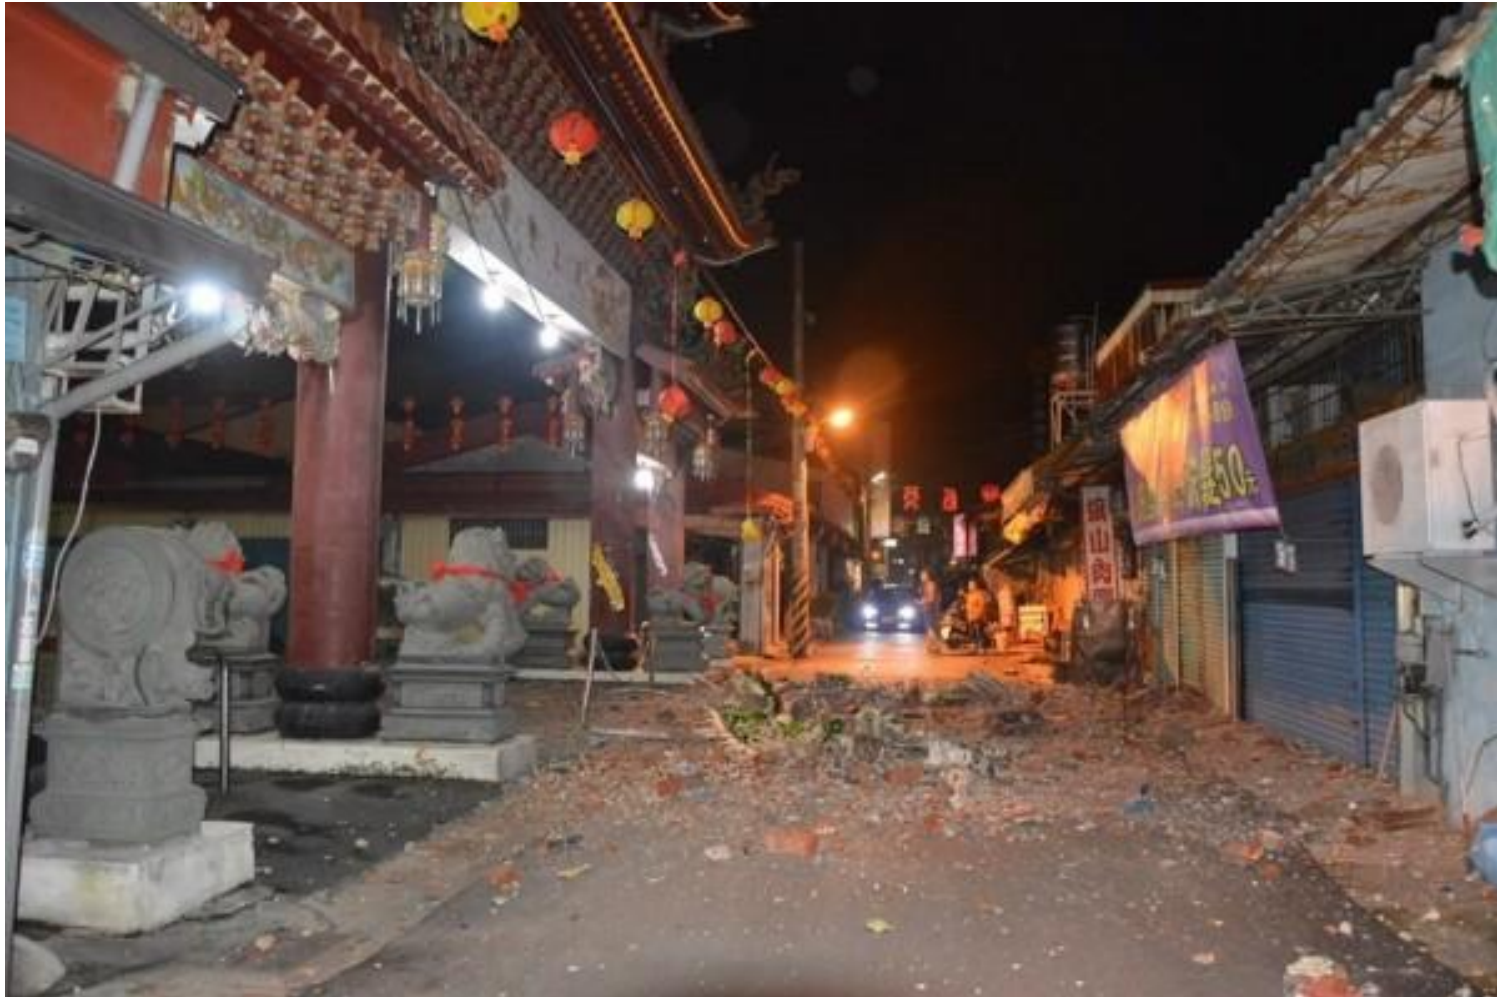
(6) Temple of Goddess Mazu, Cishan District (旗山天后宮)

- 16 Lane 23, Yongfu St., Chishan District, Kaohsiung City
- Collapse of decorated archway

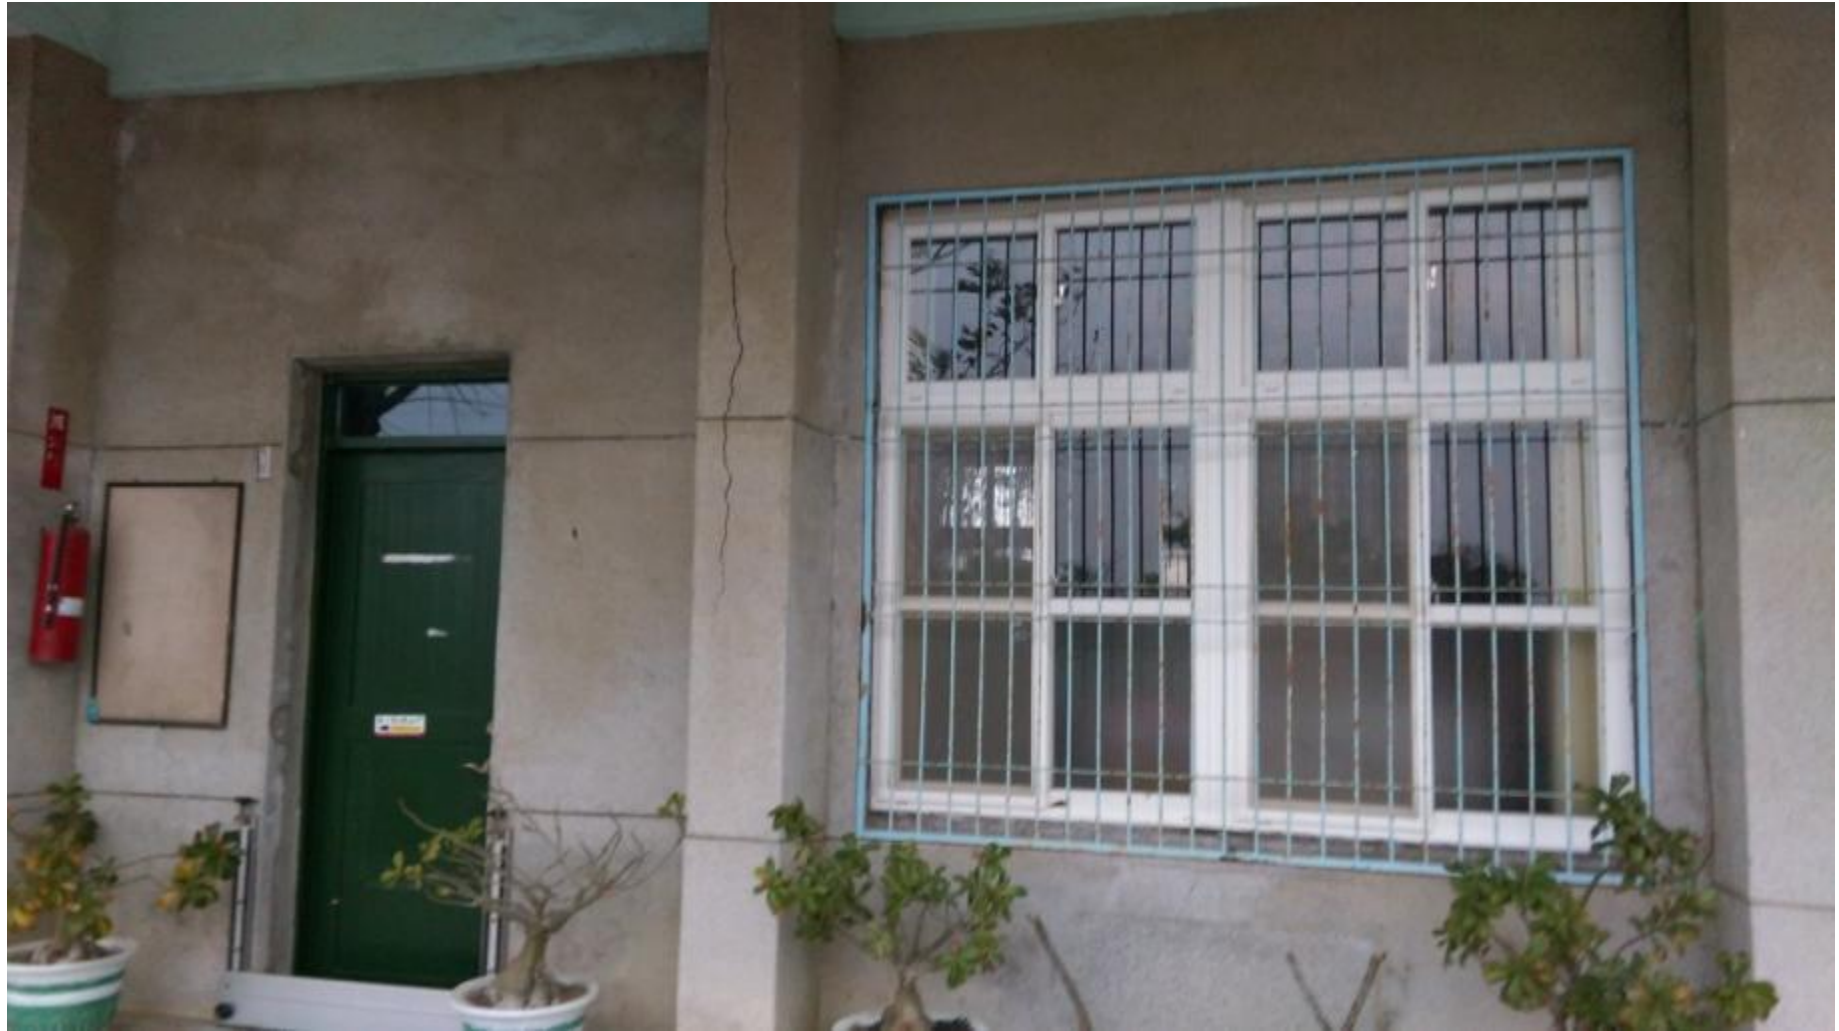
Damage of West Building, Beimen Elementary School at Yuhu Branch (北門國小玉湖分校)

◎ B2重直裂縫

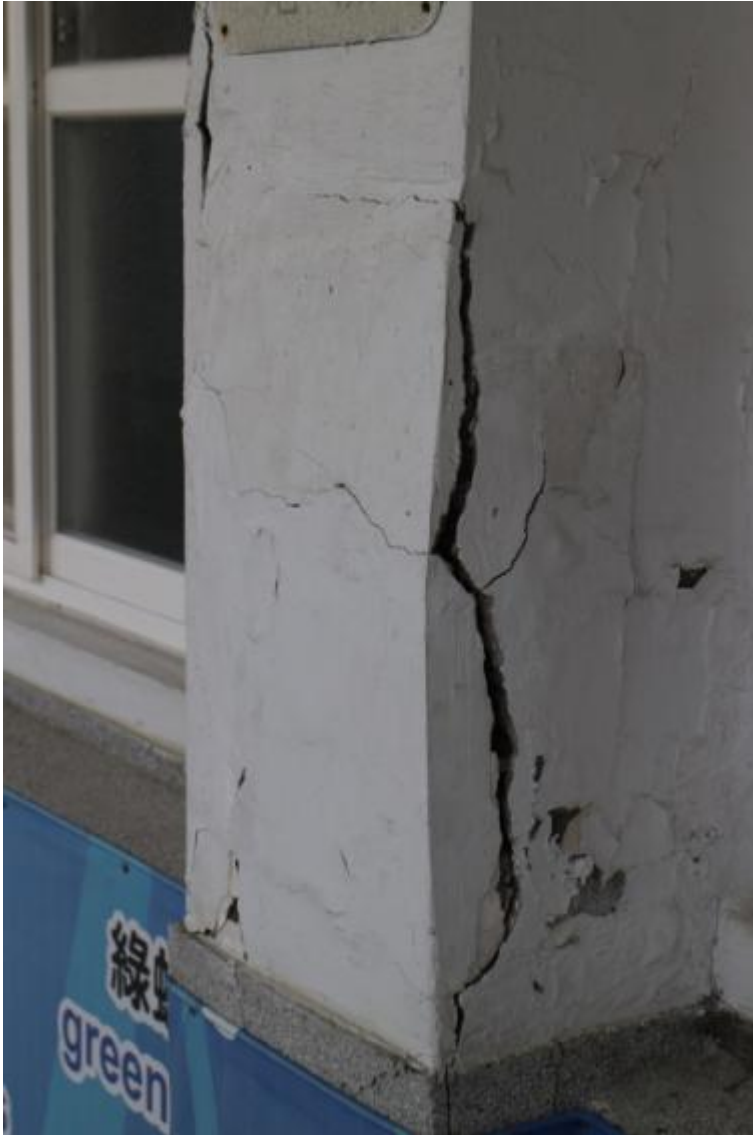
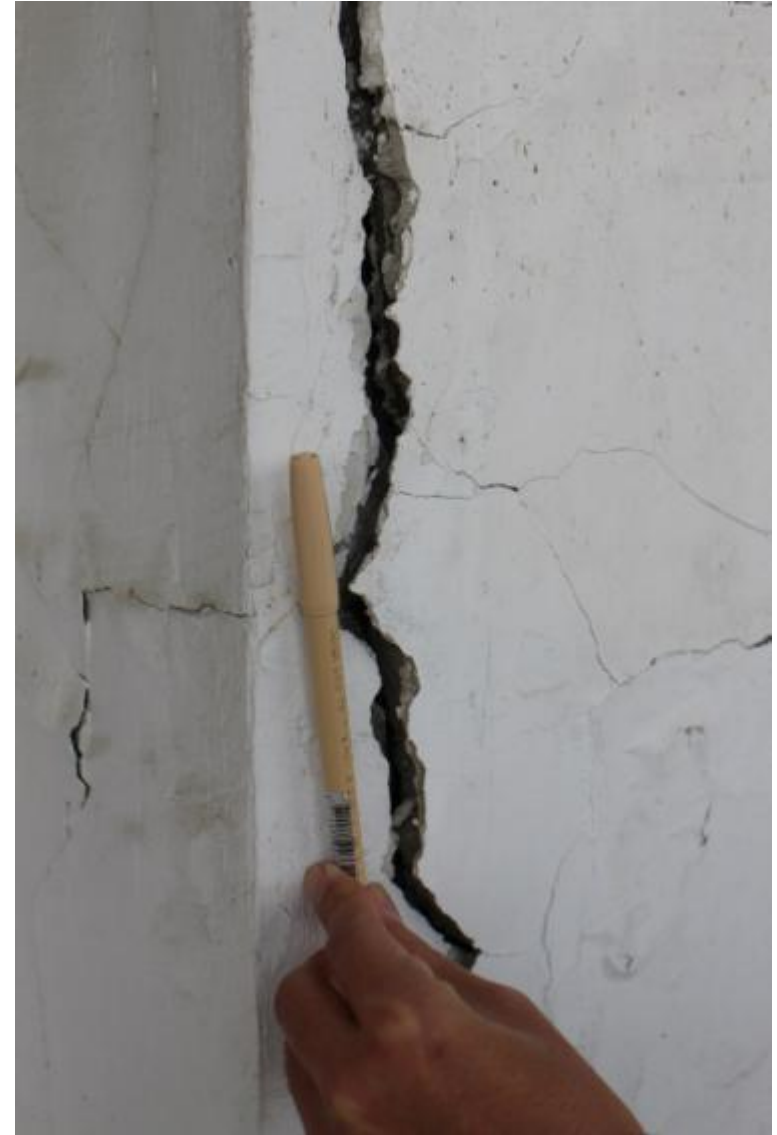
Damage of West Building, Beimen Elementary School (北門國小)

◎ B2、B6 垂直向裂縫

◎ A23梁有見主筋 (推測非此地震造成)
